**Flood Control Project Maintenance
Levee Inspections**
LMA District Cover Sheet
Spring 2019 Levee Inspection Results

Sutter Maintenance Yard East Levee Sacramento River

Spring 2019 Levee Inspection Results

Levee Inspection Report By Mile - Spring 2019

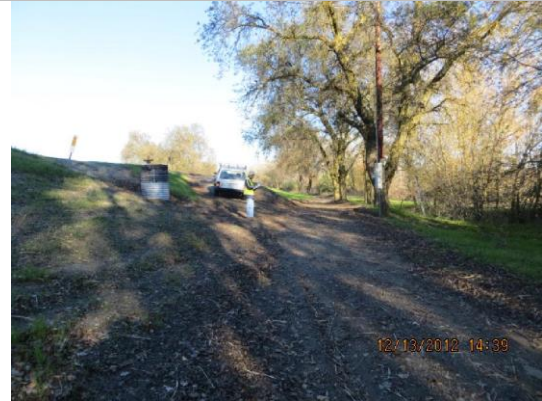
Photo 1 of 3 : UCIP_SP_2019_53399_46983.jpg

FS_ID:53399
DS_ID:17319
EP_NO: 9527
Repair Type: Urgent
Crossing Status: Found
UCIP Comments: 8/30/2018 WS vegetation completely overgrown towards walkway and pump so could not inspect. WS pipe end is nearly completely covered in debris, pipe cap appears either open or broken, LS erosion still present, and pipe end completely covered in debris so crossing remains Urgent (D. Sanoski - DWR UCIP).4/24/2017 LS slope damage is still present. No repairs have been made to this crossing yet. (DWR Sutter Yard- AFreitag)11/7/2016 No LS repairs have been made yet. (DWR Sutter Yard- AFreitag)6/6/2016 New flow meter installed on WS. Walkway to access the pump is overgrown with vegetation and not accessible. (DWR Sutter Yard - afreitag) 4/5/2016 Caved-in slope on landside (LS) not yet repaired. Leaky pipe marker gone. Per Bob Duffey (DWR FPIIB inspector), pipe will be replaced by owner next year. If not, will go to CVFPB enforcement. (DWR UCIP - kfazel)4/6/2015 Pipe leaks during times of High water. Slope damage still present. Needs a more detailed inspection to find the leak. (DWR Sutter Yard - afreitag)6/30/2014 Same as last inspection. (DWR Sutter Yard - afreitag)12/30/2013 Same as last inspection. (DWR Sutter Yard - afreitag)7/29/2013 Pipe does not appear to be abandoned. On the WS it appears that a smaller pipe was sleeved into the 18in. Pipe and then the difference capped and welded. Pump was not running at time of inspection but LS ditch near outlet was wet. LS slope damage and leaky pipe marker are still present. (DWR Sutter Yard - afreitag)12/13/2012 Abandoned and plugged/capped steel pipe on WS berm. DWR leaky pipe marker on LS (12-3). Slope failure on LS. Needs capping of LS steel pipe after detailed investigation. (DWR UCIP - pamatya)

Waterside view: overview

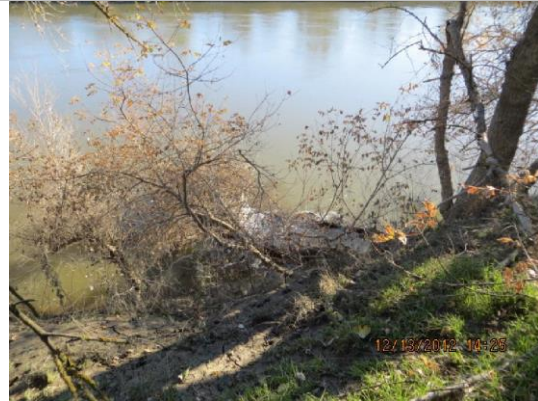
Photo 1 of 3 : UCIP_SP_2019_53400_46992.jpg

FS_ID:53400
DS_ID:17320
EP_NO: 9543
Repair Type: Urgent
Crossing Status: Found
UCIP Comments: 8/30/2018 WS vegetation too thick to clearly inspect WS pipe so assume same condition as last inspections so crossing remains Urgent due to pipe integrity. WS levee slope looks good. No signs of levee threat to the road crown. LS headwall looks in good condition (D. Sanoski - DWR UCIP).4/24/2017 WS was underwater during the site visit but I do not believe that any repairs have been made to this crossing yet. (DWR Sutter Yard- AFreitag)11/7/2016 No repairs have been made here yet. (DWR Sutter Yard- AFreitag)6/17/2016 River levels were down and the WS pipe end was exposed. WS end is completely rotten and damaged and flap gate has fallen off the end of the pipe (see pics). Pipe needs to be replaced or repaired. (DWR Sutter Yard - afreitag)4/5/2016 Erosion on WS slope still present. Pipe still fully submerged on WS and discharging into river during site visit. (DWR UCIP - kfazel)4/6/2015 Pipe leaks during high water. DWR employee said he suspects that the flap gate has rotted and fallen off WS end of pipe. Could not locate WS end of pipe to confirm. Water was flowing through this drain during field survey. (DWR Sutter Yard - afreitag)6/30/2014 Same as last inspection. (DWR Sutter Yard - afreitag)12/30/2013 Same as last inspection. (DWR Sutter Yard - afreitag)7/29/2013 Same as last inspection. (DWR Sutter Yard - afreitag) 12/13/2012 Water was flowing through this drain during field survey. (DWR UCIP - pamatya)

Waterside view: overview of river bank

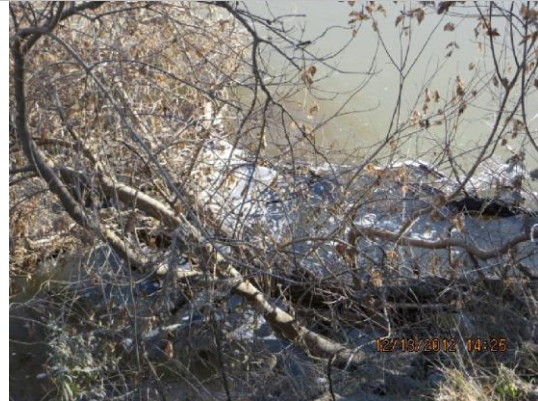
Photo 2 of 3 : UCIP_SP_2019_53400_46991.jpg

FS_ID:53400
DS_ID:17320
EP_NO: 9543
Repair Type: Urgent
Crossing Status: Found
UCIP Comments: 8/30/2018 WS vegetation too thick to clearly inspect WS pipe so assume same condition as last inspections so crossing remains Urgent due to pipe integrity. WS levee slope looks good. No signs of levee threat to the road crown. LS headwall looks in good condition (D. Sanoski - DWR UCIP).4/24/2017 WS was underwater during the site visit but I do not believe that any repairs have been made to this crossing yet. (DWR Sutter Yard- AFreitag)11/7/2016 No repairs have been made here yet. (DWR Sutter Yard- AFreitag)6/17/2016 River levels were down and the WS pipe end was exposed. WS end is completely rotten and damaged and flap gate has fallen off the end of the pipe (see pics). Pipe needs to be replaced or repaired. (DWR Sutter Yard - afreitag)4/5/2016 Erosion on WS slope still present. Pipe still fully submerged on WS and discharging into river during site visit. (DWR UCIP - kfazel)4/6/2015 Pipe leaks during high water. DWR employee said he suspects that the flap gate has rotted and fallen off WS end of pipe. Could not locate WS end of pipe to confirm. Water was flowing through this drain during field survey. (DWR Sutter Yard - afreitag)6/30/2014 Same as last inspection. (DWR Sutter Yard - afreitag)12/30/2013 Same as last inspection. (DWR Sutter Yard - afreitag)7/29/2013 Same as last inspection. (DWR Sutter Yard - afreitag) 12/13/2012 Water was flowing through this drain during field survey. (DWR UCIP - pamatya)

Waterside view: water flowing from outlet pipe (pipe fully submerged)

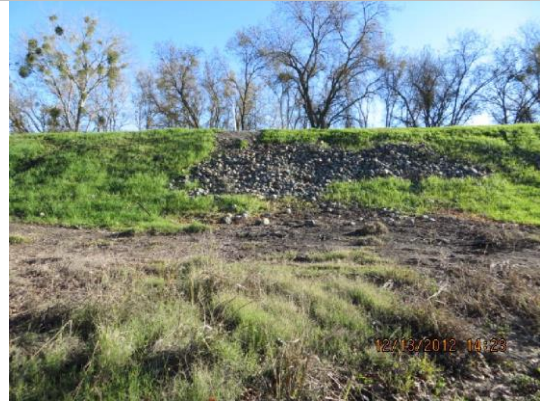
Photo 3 of 3 : UCIP_SP_2019_53400_46990.jpg

Comment Code					
Inspector Comment					
FS_ID:53400 DS_ID:17320 EP_NO: 9543 Repair Type: Urgent Crossing Status: Found UCIP Comments: 8/30/2018 WS vegetation too thick to clearly inspect WS pipe so assume same condition as last inspections so crossing remains Urgent due to pipe integrity. WS levee slope looks good. No signs of levee threat to the road crown. LS headwall looks in good condition (D. Sanoski - DWR UCIP).4/24/2017 WS was underwater during the site visit but I do not believe that any repairs have been made to this crossing yet. (DWR Sutter Yard- AFreitag)11/7/2016 No repairs have been made here yet. (DWR Sutter Yard- AFreitag)6/17/2016 River levels were down and the WS pipe end was exposed. WS end is completely rotten and damaged and flap gate has fallen off the end of the pipe (see pics). Pipe needs to be replaced or repaired. (DWR Sutter Yard - afreitag)4/5/2016 Erosion on WS slope still present. Pipe still fully submerged on WS and discharging into river during site visit. (DWR UCIP - kfazel)4/6/2015 Pipe leaks during high water. DWR employee said he suspects that the flap gate has rotted and fallen off WS end of pipe. Could not locate WS end of pipe to confirm. Water was flowing through this drain during field survey. (DWR Sutter Yard - afreitag)6/30/2014 Same as last inspection. (DWR Sutter Yard - afreitag)12/30/2013 Same as last inspection. (DWR Sutter Yard - afreitag)7/29/2013 Same as last inspection. (DWR Sutter Yard - afreitag) 12/13/2012 Water was flowing through this drain during field survey. (DWR UCIP - pamatya) FIELD_STRUCT_DESC: 30-inch corrugated metal drainage pipe (at 45 degrees) through the levee, 25.2 feet below the crown. Flap gate on the waterside (WS), not found in 2016. (30-inch pipe [HLM 1.38] authorized under Automatic Board Order (ABO) issued as Permit No. 9543, 1974 - Harada). [Additional Reference(s): DWR Levee Log, 2002. USACE Sacramento O&M Manual 136, revision March 1960 (HLM 1.38)] FS Date: 8/30/2018 1:02:00 PM

Landside view: overview of levee slope

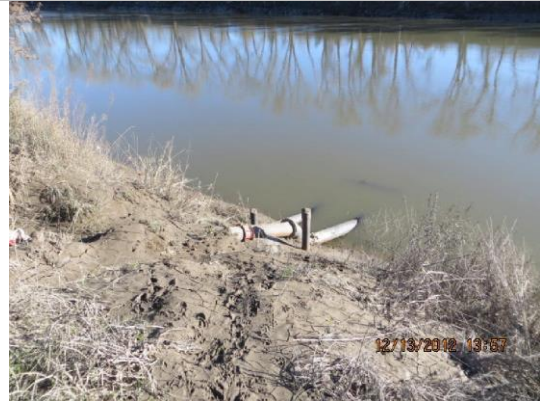
Photo 1 of 3 : UCIP_SP_2019_52947_47004.jpg

FS_ID:52947
 DS_ID:17321
 EP_NO: 9543
 Repair Type: Non-Urgent
 Crossing Status: Found
 UCIP Comments: 8/30/2018 BRAND-NEW pipe and pump structure installed at this location. Pump in operation at time of inspection and no leaks were visible. Downgraded to Non-Urgent; will be further downgraded to No Action Needed when paperwork compliance with CVFPB is confirmed (D. Sanoski - DWR UCIP).4/24/2017
 Abandoned and needs to be done so properly. Vegetation was to thick on the LS slope to see and sloughing or slope damage. (DWR Sutter Yard- AFreitag)11/7/2016 Abandoned. (DWR Sutter Yard- AFreitag)6/17/2016 Abandoned crossing. (DWR Sutter Yard - afreitag)4/5/2016 Appears abandoned and should be done so properly. LS levee slope has a slight but sudden drop (could be due to improper compaction). Dense vegetation on LS prevented visibility of sloughing or other damage to levee. Could not locate leaky pipe marker. Per Bryan Reniff of Sutter Yard, marker was previously installed due to a high water event, not leaky pipe. Appears repair work to levee performed but unclear of extent. Gate valve on WS is bent and damaged, appears abandoned. Crossing a good candidate for video inspection. (DWR UCIP - kfazel)4/6/2015 Sloughing LS slope and river bank. DWR marking for leaky pipe. (DWR Sutter Yard - afreitag)6/30/2014 Same as last inspection. (DWR Sutter Yard - afreitag)12/30/2013 Same as last inspection. (DWR Sutter Yard - afreitag)7/29/2013 Same as last inspection. (DWR Sutter Yard - afreitag)12/13/2012 Sloughing LS slope and river bank. DWR marking for leaky pipe. (DWR UCIP - pamatya)

Waterside view: pipe @river bank

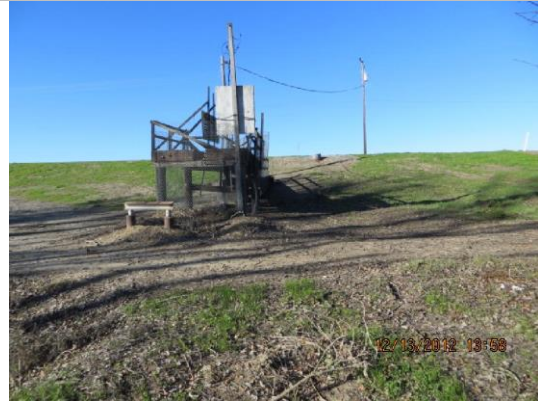
Photo 2 of 3 : UCIP_SP_2019_52947_47003.jpg

FS_ID:52947
DS_ID:17321
EP_NO: 9543
Repair Type: Non-Urgent
Crossing Status: Found
UCIP Comments: 8/30/2018 BRAND-NEW pipe and pump structure installed at this location. Pump in operation at time of inspection and no leaks were visible. Downgraded to Non-Urgent; will be further downgraded to No Action Needed when paperwork compliance with CVFPB is confirmed (D. Sanoski - DWR UCIP).4/24/2017
Abandoned and needs to be done so properly. Vegetation was to thick on the LS slope to see and sloughing or slope damage. (DWR Sutter Yard- AFreitag)11/7/2016 Abandoned. (DWR Sutter Yard- AFreitag)6/17/2016 Abandoned crossing. (DWR Sutter Yard - afreitag)4/5/2016 Appears abandoned and should be done so properly. LS levee slope has a slight but sudden drop (could be due to improper compaction). Dense vegetation on LS prevented visibility of sloughing or other damage to levee. Could not locate leaky pipe marker. Per Bryan Reniff of Sutter Yard, marker was previously installed due to a high water event, not leaky pipe. Appears repair work to levee performed but unclear of extent. Gate valve on WS is bent and damaged, appears abandoned. Crossing a good candidate for video inspection. (DWR UCIP - kfazel)4/6/2015 Sloughing LS slope and river bank. DWR marking for leaky pipe. (DWR Sutter Yard - afreitag)6/30/2014 Same as last inspection. (DWR Sutter Yard - afreitag)12/30/2013 Same as last inspection. (DWR Sutter Yard - afreitag)7/29/2013 Same as last inspection. (DWR Sutter Yard - afreitag)12/13/2012 Sloughing LS slope and river bank. DWR marking for leaky pipe. (DWR UCIP - pamatya)

Waterside view: abandoned pump station.

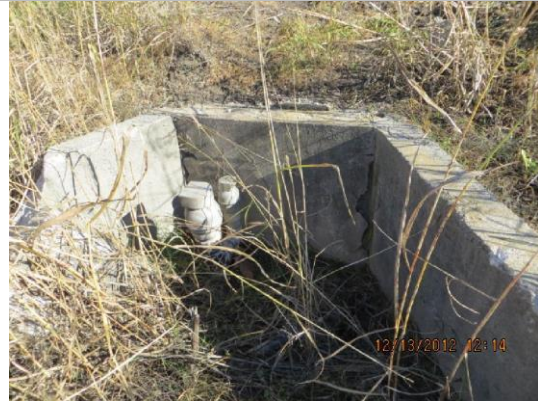
Photo 1 of 3 : UCIP_SP_2019_53401_47049.jpg

Waterside view: plugged concrete structure and siphon breakers

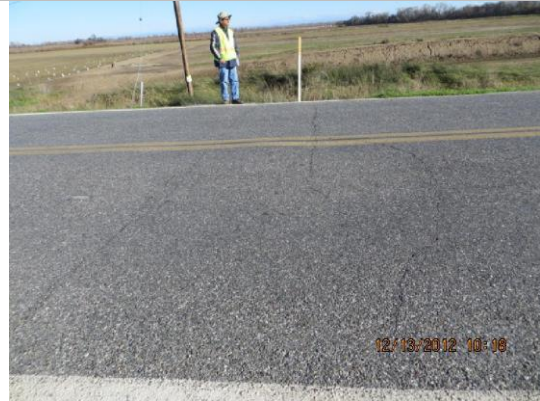
Photo 1 of 3 : UCIP_SP_2019_52952_47068.jpg

Crown view: transverse cracks on levee road.

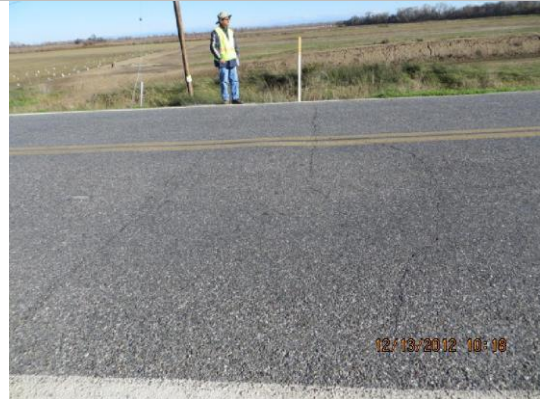
Photo 1 of 3 : UCIP_SP_2019_52953_47080.jpg

Crown view: cracks along pipe alignment (transverse crack)

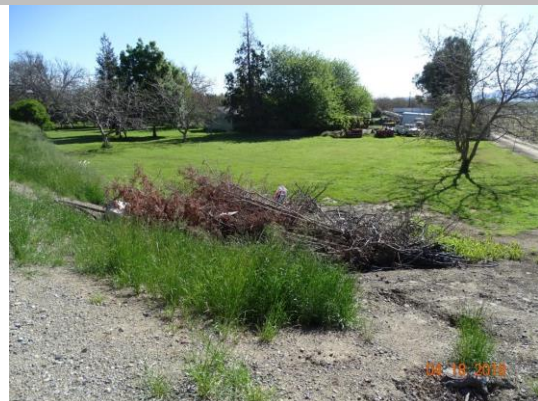
Photo 1 of 1 : SP_2019_ST0003_264_112_20190327_00029.jpg

View of the prunings along the landside toe.

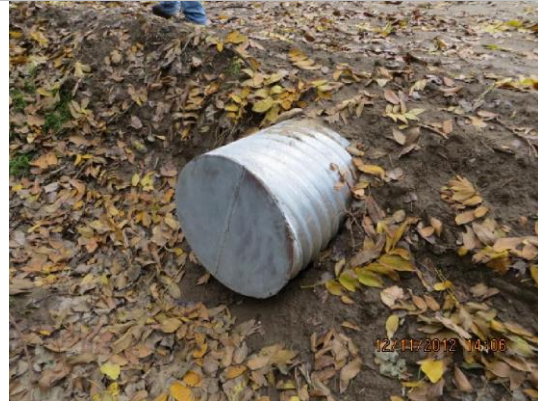
Photo 3 of 3 : UCIP_SP_2019_51731_47240.jpg

Waterside view: capped CMP pipe

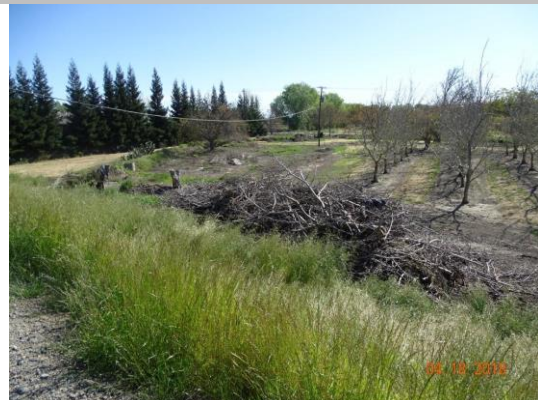
Photo 1 of 1 : SP_2019_ST0003_264_113_20190327_00030.jpg

View of the prunings along the landside toe.

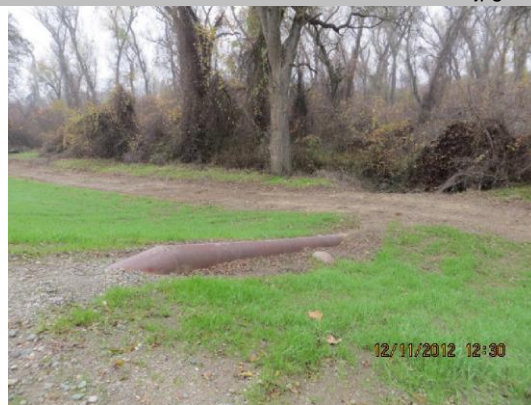
Photo 2 of 3 : UCIP_SP_2019_51737_47283.jpg

Waterside view: overview of exposed steel pipe

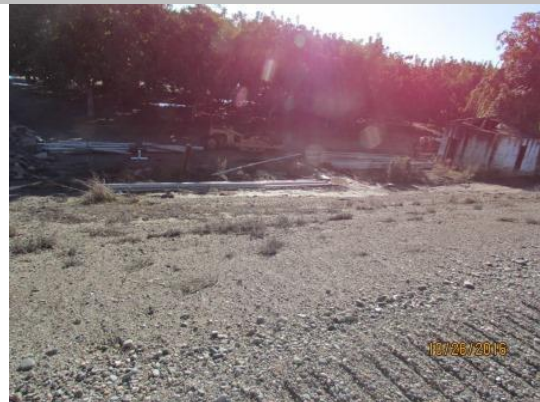
Photo 1 of 1 : SP_2019_ST0003_264_76_20190327_00016.jpg

View of the ag equipment along the landside toe.

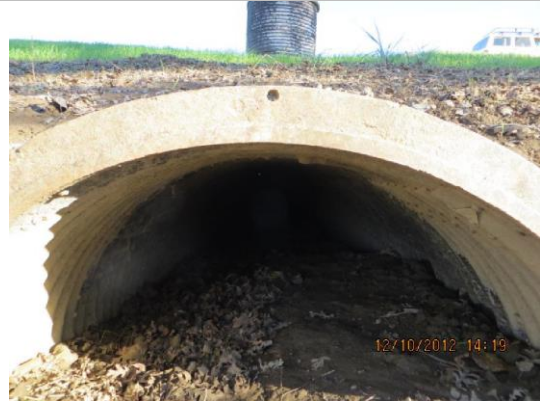
Photo 3 of 3 : UCIP_SP_2019_51749_47341.jpg

Waterside view: silted concrete lined CMP outlet pipe

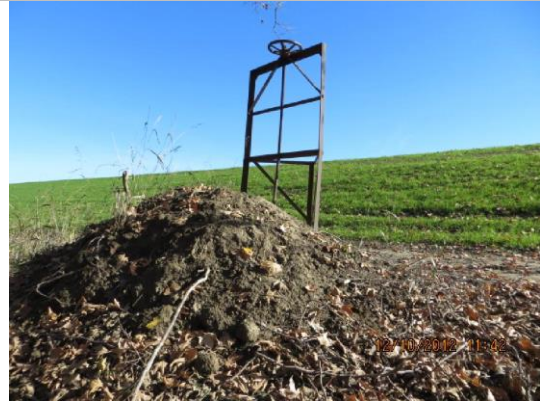
Photo 3 of 3 : UCIP_SP_2019_51760_47378.jpg

Waterside view: silt and debris in front of slide gate

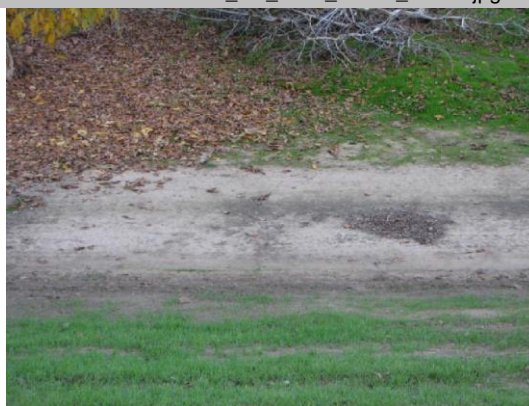
Photo 1 of 3 : UCIP_SP_2019_51762_47384.jpg

Landside view: overview. No pipe found.

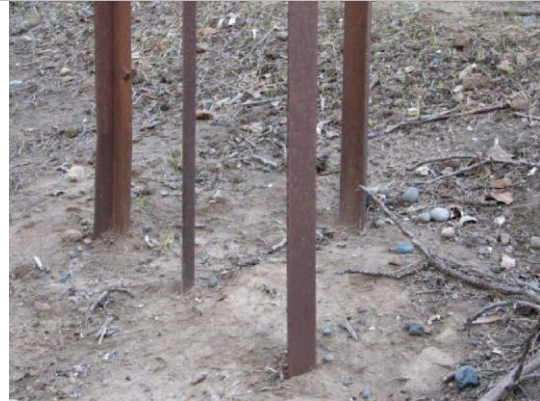
Photo 3 of 3 : UCIP_SP_2019_51762_47385.jpg

Waterside view: buried slide gate

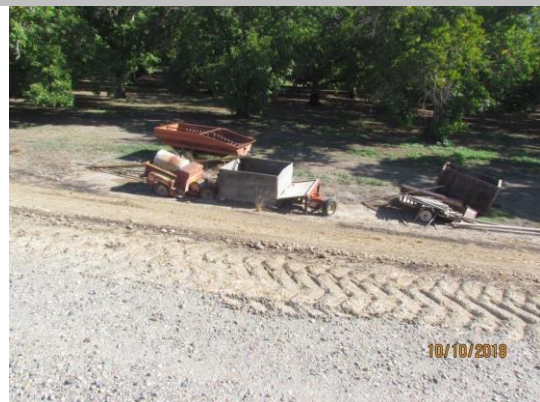
Photo 1 of 1 : SP_2019_ST0003_264_96_20190327_00022.jpg

View of the equipment along the landside toe.
